# Test Report

Report No. A2230007151101001

Sample Name T-BAT-SYS-HV-S2.5

No.	Test Item
1	Vibration test (No packaging)
2	Random vibration test (No packaging)
3	Random vibration test (package)

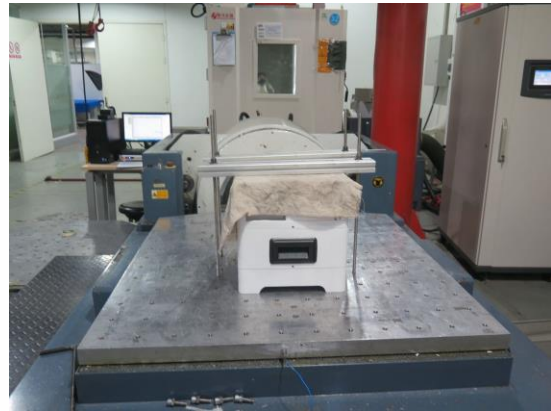
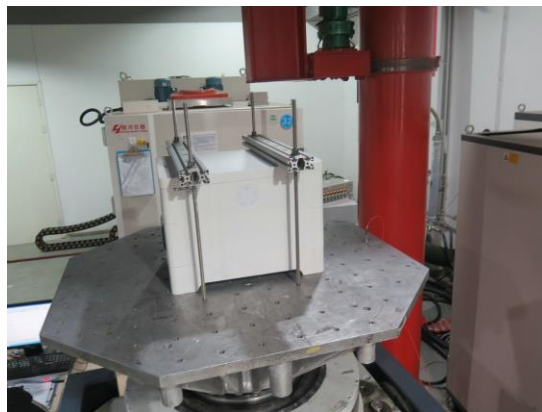
Frequency (Hz)	Acceleration (m/s <sup>2</sup> )	Amplitude (mm)	Test Direction	Test duration
10-58	/	0.075	X、Y、Z	10cycles/axis
58-150	10	/		
Sweep rate: 1oct/min

X

Y

Z

Sample No.	Test Result(s)
A2230007151101001	After the test, there was no visible mechanical damage on the sample by visual inspection.

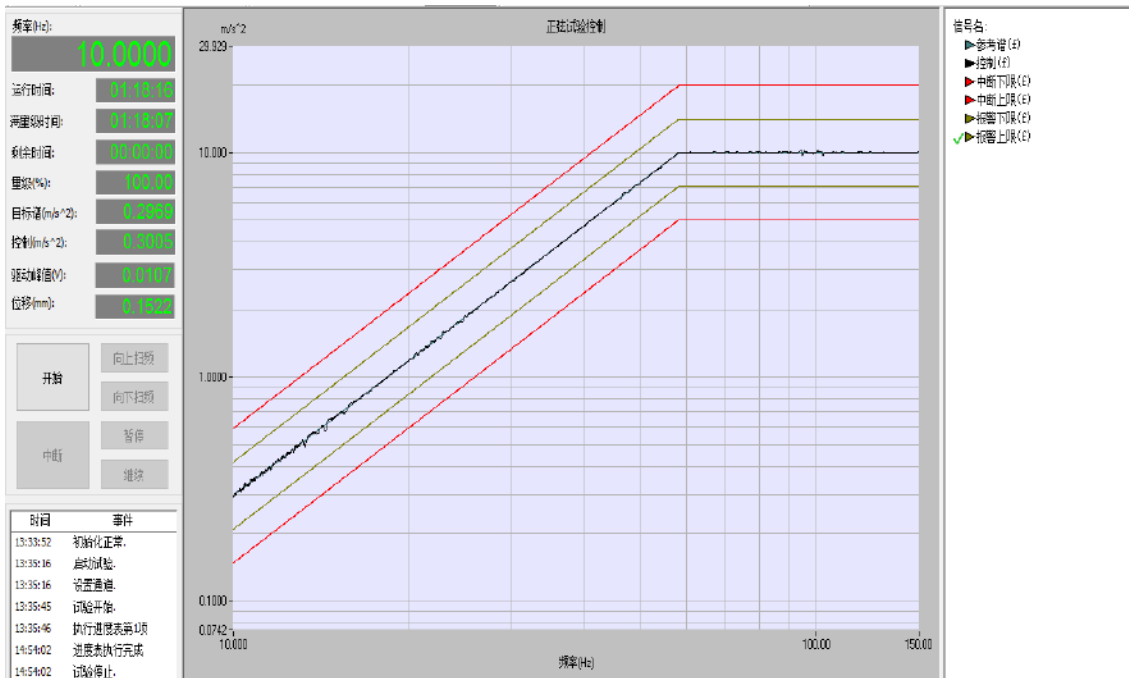
### Test Curve

X

Y

Z

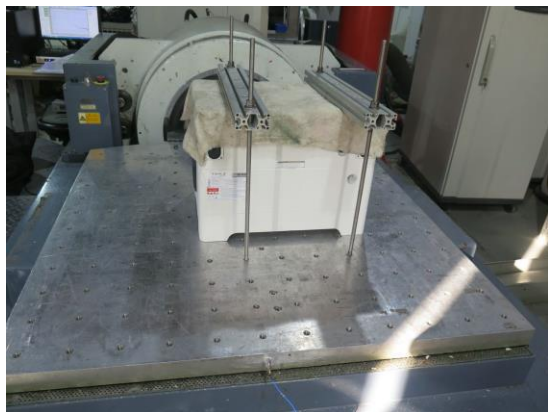
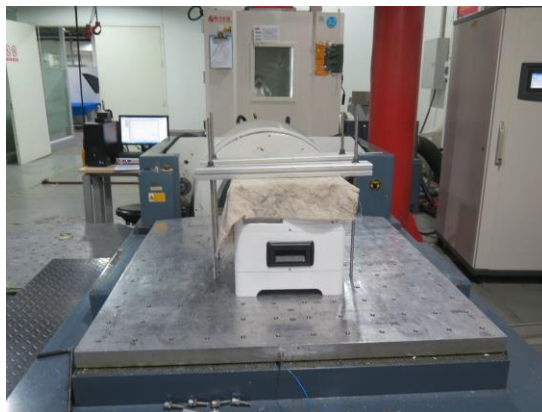
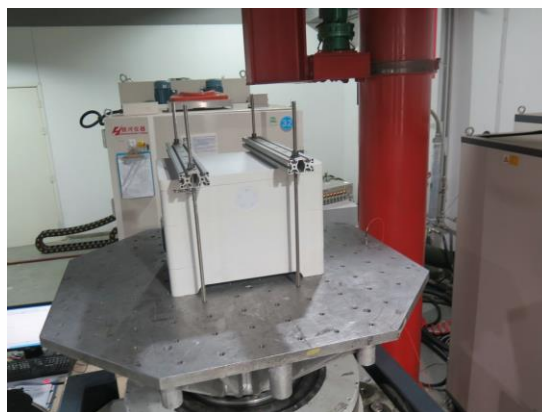
Frequency (Hz)	PSD(( m/s <sup>2</sup> ) <sup>2</sup> /Hz)	Test direction	Test duration	g rms ( m/s <sup>2</sup> )
10	0.022	X、Y、Z	1h/axis	7.0
30	0.2			
200	0.2			
500	0.0052

X

Y

Z

Sample No.	Test Result(s)
A2230007151101001	After the test, there was no visible mechanical damage on the sample by visual inspection.

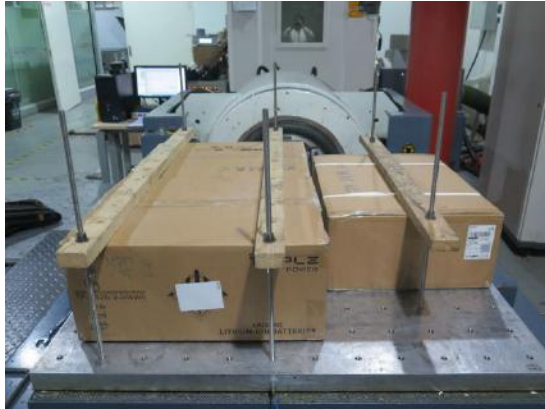
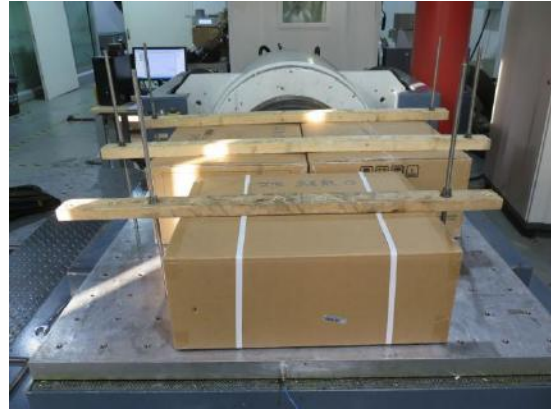
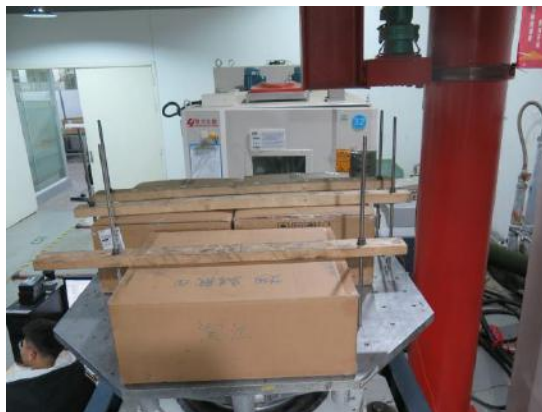
Frequency (Hz)	PSD(( m/s <sup>2</sup> ) <sup>2</sup> /Hz)	Test direction	Test duration	g rms (m/s <sup>2</sup> )
10	1.0	X、Y、Z	30min/axis	18.7
10	1.0			
200	1.0			
500	0.3

X

Y

Z

Sample No.	Test Result(s)
A2230007151101001	After the test, there was no visible mechanical damage on the sample by visual inspection.
